# **DEBRIS FLOWS: Disasters, Risk, Forecast, Protection**

Chengdu, China, 23–27 September 2024

## Hazard potential change for rain-induced debris flow in silty clay mudstone environment after large earthquake and continuous rainfall sediment deposit

B.-S. Lin, H.-C. Hsu, W.-Y. Chiu, F.Y. Kuo

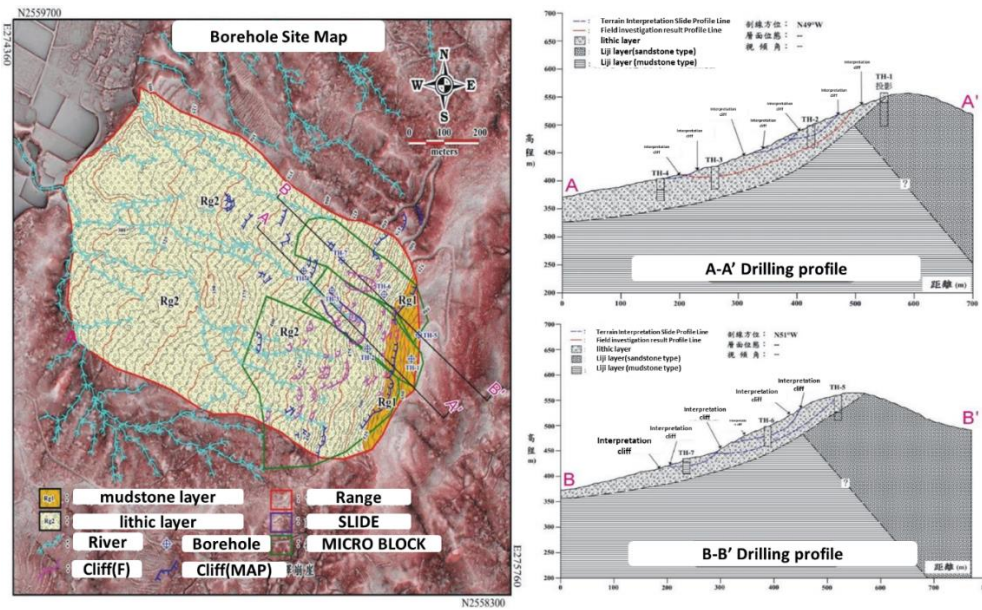
In 2018, the Soil and Water Conservation Bureau planned 7 geological boreholes from TH-1 to TH-7 in this area, with a total drilling depth of 300 m. The borehole layout and investigation purpose are shown in Fig. 4. In addition, the ground resistance detection includes 4 measuring lines such as H1~H4. The length of the measuring lines ranges from 200 m to 450 m, and the total length of the measuring lines is 1150 m. Drilling results show that the lithology within the site area is mainly blue-gray or gray-black mudstone, mixed with a large number of brecciated rock blocks. The composition of the rock blocks can be seen as tuffaceous sandstone, hard shale, andesitic clastic rock and ophiolite [CGS, 2018; SWCB, 2018]. Its heterogeneous rock blocks, with particle sizes ranging from several centimeters to several meters, are relatively fragmented due to strong shearing. Excerpts of borehole configuration and geological profile results are shown in Fig. 4.

According to the core analysis of drilling in 2018, the thickness of the debris layer in the large-scale landslide potential area ranges from 17.4 meters to a maximum depth of more than 40 meters. It is mainly composed of colluvial gravel and broken rock layers. The gravel composition is composed of igneous rock blocks, mainly sandstone blocks and mudstone blocks. Since the mudstone of the Liji Formation has no bedding and the surface is composed of lithic layers, there is no bedding position data within the scope of this research. According to the surface geological survey and drilling results of the large-scale landslide potential area, it is shown that the scope of this research should be an old large-scale landslide potential area. It is speculated that it is a collapse in the debris layer, which is an arc-shaped sliding type. The area where it occurs (i.e., the head) is an independent hilltop composed of sandstone blocks located on the east side of the collapse area, and is determined to be the earliest location where the collapse occurred.

Fig. 4. Excerpts of the past-year geological survey results of T004

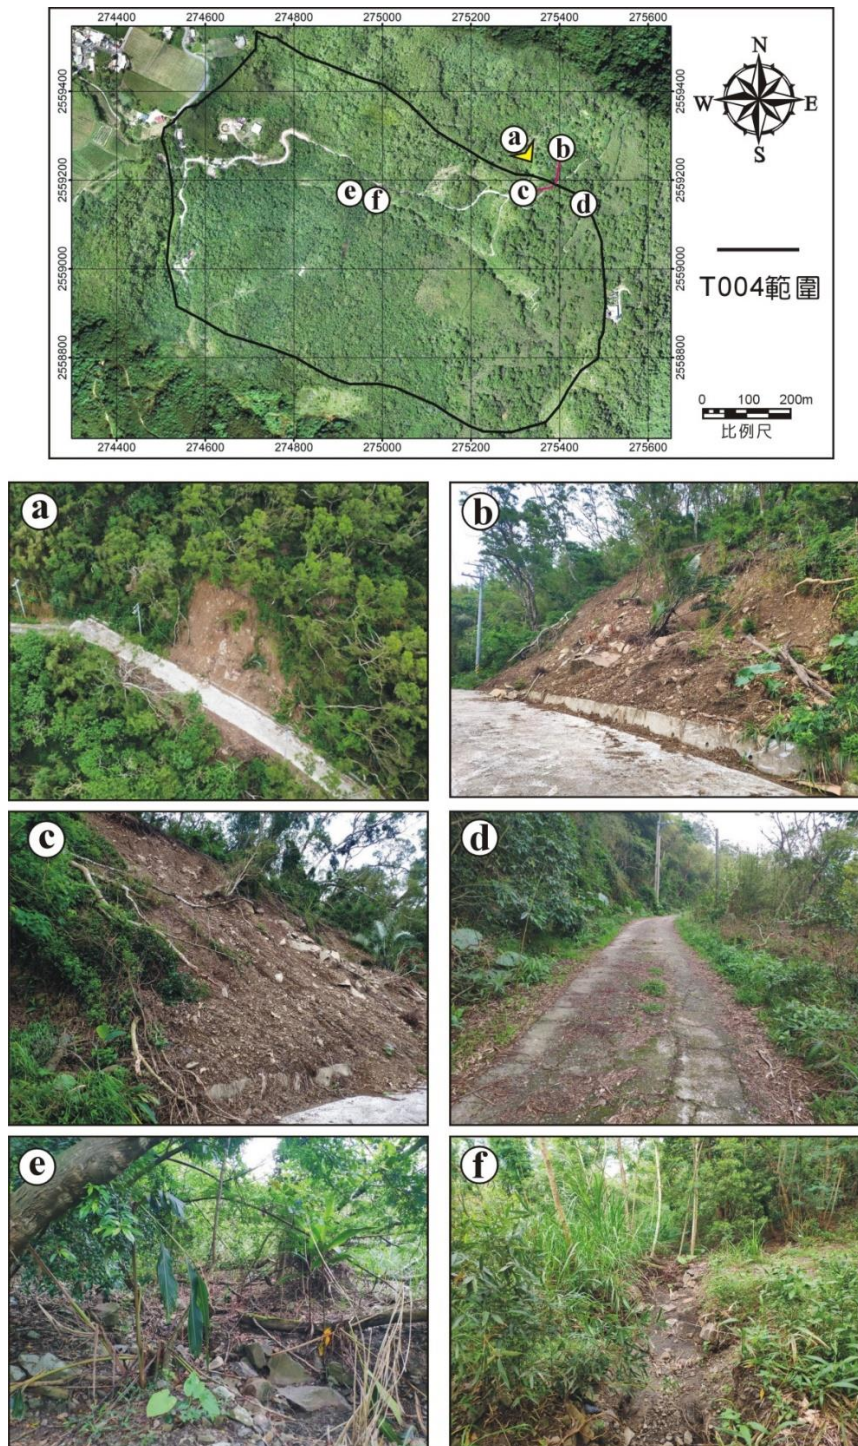
The survey results and on-site photos of surface fissures in the Dian-Tai Mountain site area last year (2023) are shown in Fig. 6. It can be found from the survey results that surface cracks are mainly located on the connecting roads leading to the top of the slope, mostly in the form of road cracks, and cracks also occur in local retaining walls. The distribution of cracks is mainly concentrated on the road pavement in the middle section of the slope. The types are mainly longitudinal cracks and irregular cracks. Damage to drainage ditches can also be seen in local areas (Fig. 6); damage to retaining walls is mainly concentrated in the location of area B in Fig. 7. Although there are many cracks in the remaining areas of this survey area, such as the road surface near the top of the slope and around the radio station, and the farm road near the toe of the slope, they should be related to the construction quality or local terrain, rather than caused by ground slippage.

Generally speaking, surface fissures in the Dian-Tai Mountain site area are mostly distributed near the middle section of the slope, and are less likely to occur in the sandstone layer area on the top of the slope. The reason may be that these cracks are mostly caused by shallow sliding, so they mostly occur in the colluvium accumulation area in the middle section of the slope.

Fig. 6. Shallow damage and erosion in T004 (2023.10.15)

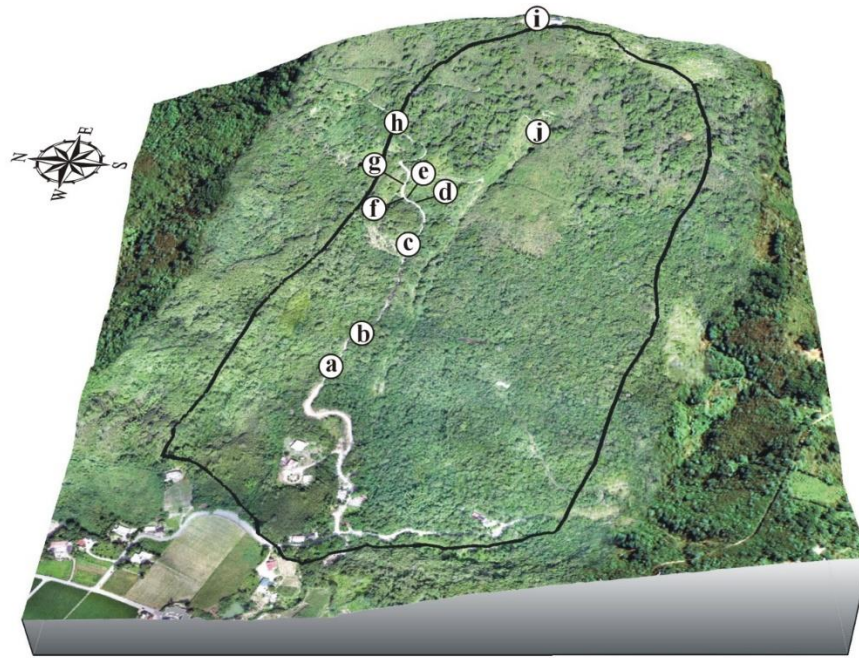
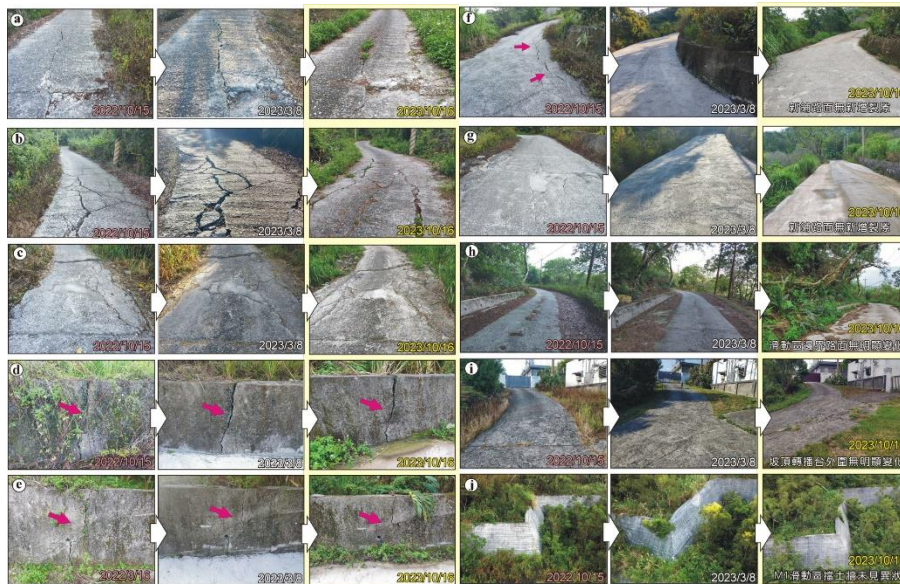
Fig. 7 shows the results of the investigation of fissure changes in this area from October 2011 to October 2020. The description is as follows:

1. There are no obvious changes in the existing cracks in the road surface in the middle and lower sections of the slope (photos *a* and *b* in Fig. 7). After repairing part of the road surface damaged by the earthquake, there were no new cracks in the filled areas (photo *c* in Fig. 7).
2. There is no obvious change in the cracks in the road retaining wall in the middle section of the slope (photos *d* and *e* in Fig. 7). Some of the damaged retaining walls in this section have been repaired and rebuilt, and no cracks are found in the new retaining walls.
3. The road pavement in the middle section of the slope was originally an area with developed cracks. The pavement was re-paved in mid-2011, but new cracks were

discovered during the investigation in October 2011. During the survey in March of this year (2012), it was found that the road surface had been re-paved. When the survey was carried out again in October, no new cracks were found in the road surface (Fig. 7, photos *f*, *g*).

4. The survey results of the road surface on the upper slope of the survey area showed no significant changes (photo *h* in Fig. 7); there was also no significant change in the road surface around the radio station on the top of the slope (photo *i* in Fig. 7).

5. There are no signs of damage or other abnormalities in the newly constructed retaining wall in the upper slope improvement research of the M1 sliding area, and the surrounding sliding soil is gradually revegetated (photo *j* in Fig. 7).

Fig. 7. Comparative photos of changes in surface fissures

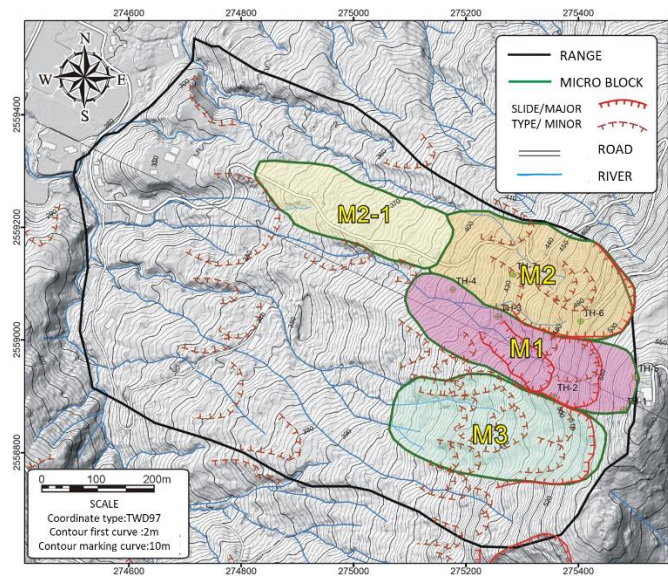
Referring to the previous survey results of this research scope, there are two large-scale landslide potential areas, M1 and M2, on the upper slope of the T004 range. In 110, Dian-Tai Mountain was divided into blocks, and it was found that there was a potential collapse area on the right side of the M1 block. Sliding block, so the M3 sliding block was added. However, since the M3 block has no accessible road and the signs of sliding are unclear, it is tentatively planned not to conduct relevant monitoring. Based on the results of high-precision numerical terrain interpretation, this plan considers the sliding direction and impact area of slope soil, as well as the location and direction of water systems and ridge lines, and re-targets the sliding blocks M1, M2 and M3 in the T004 large-scale landslide potential area. The boundaries are divided, and the result is shown in Fig. 8 Among them, considering the investigation results of surface damage phenomena, an additional sliding block M2-1 was designated on the middle

slope below the M2 block. The delineation results are shown in Fig. 8 and the current 3D terrain and slope surface are shown in Fig. 9.

Fig. 8. Division of sliding blocks in T004

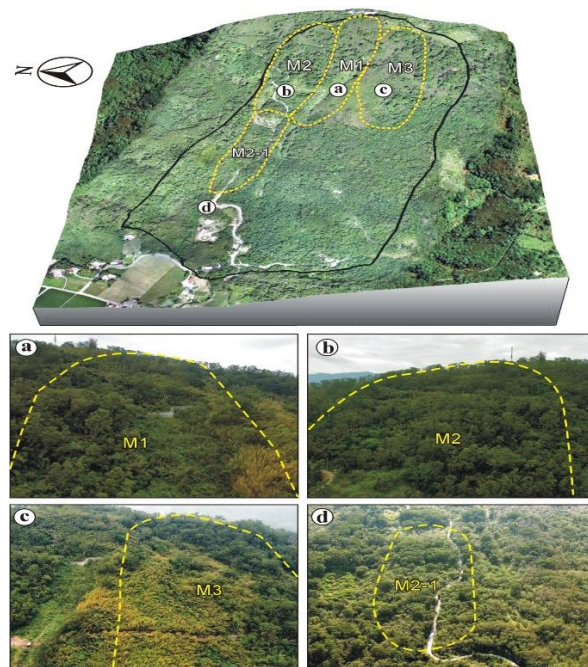
Fig. 9. Full view T004 Sliding block division (2023.10.15)

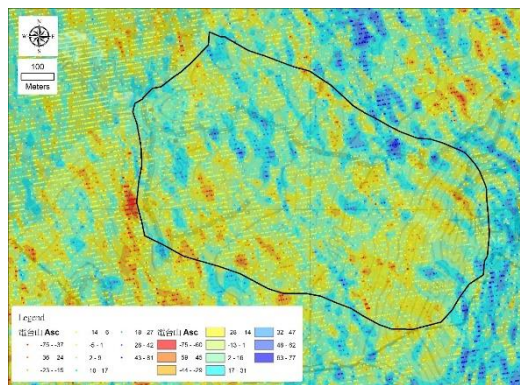
From this analysis to September 2023, the analysis results of the ascending orbit from the previous period to the end of this analysis are shown in Fig. 12. The decrease in head elevation can also be observed on the slope, but it is limited by the satellite incident direction. and the slope aspect within the range, a descending rail analysis must still be performed; the descending rail analysis results are shown in Fig. 13 [SWCB, 2023]. For past event of No21 Typhoon in 2021 and 0323 and 0918 earthquake ( $> M6.8$ ) in 2022, the surface deformation can be seen that the slope slides from southeast to northwest, in Fig. 14 and the solution results will be that the head falls and the toe rises, and the reaction may exist Multiple sliding surfaces or partial sliding blocks can be supplemented and verified by underground monitoring.

Fig. 12. Vertical deformation of the rising rail satellite from 2023/5 to 2023/9 (unit: mm)
